AAA Home and Termite Inspections

Property Inspection Report

12200 Inspectors Dr, El Paso, TX 79938
Inspection prepared for: John Doe & Jane Doe
Date of Inspection: 12/17/2012 Time: 8a
Age of Home: 2012 Size: 2000sq ft
Weather: 43deg F

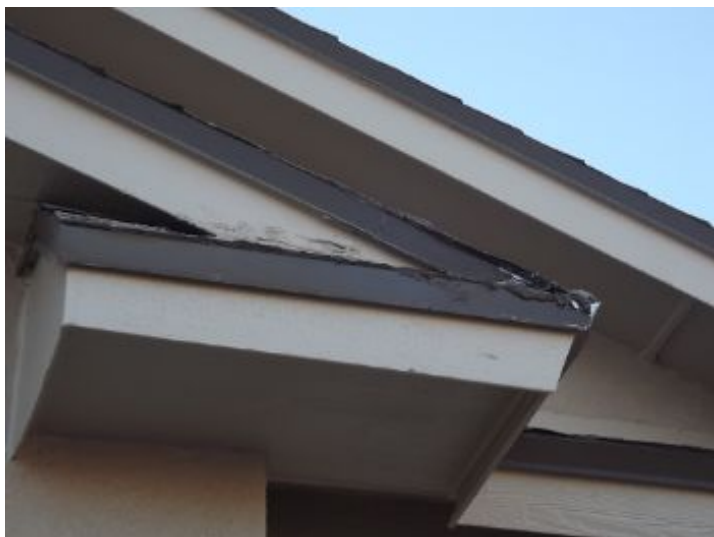
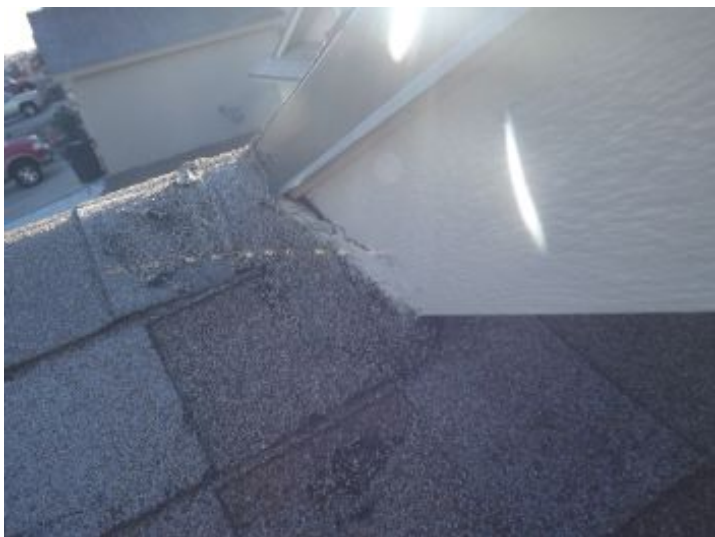
- **Certain areas of roof were unsealed, or needed more weather proofing via tar and granulars, recommend correction by licensed professional**

Certain areas of roof were unsealed, or needed more weather proofing via tar and granulars, recommend correction by licensed professional

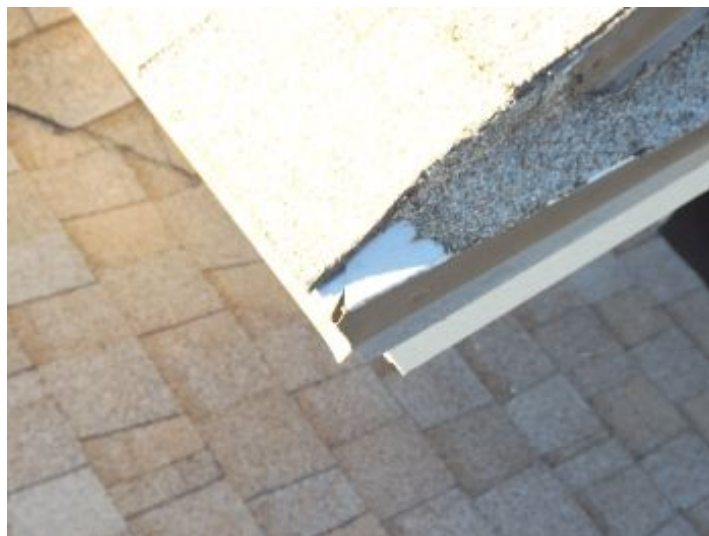
Certain areas of roof were unsealed, or needed more weather proofing via tar and granulars, recommend correction by licensed professional

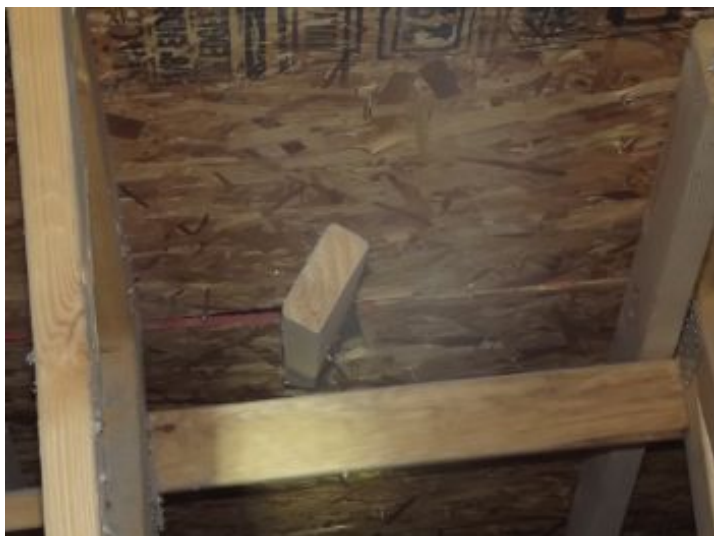
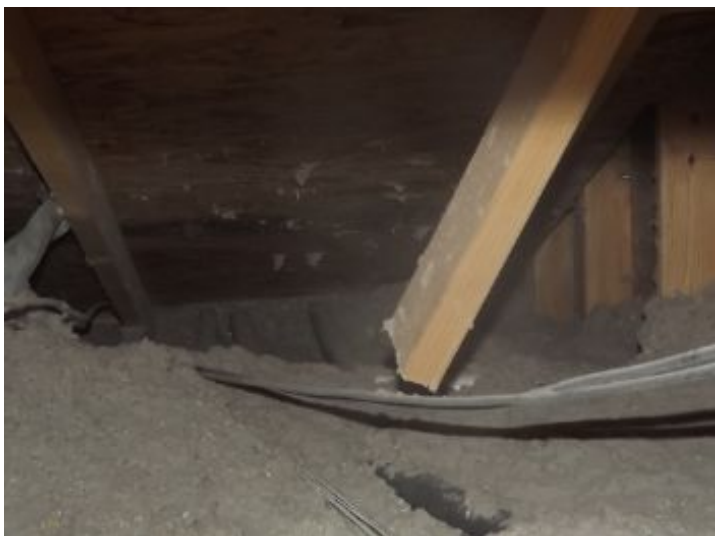
- Exterior light was visible from attic, wood member within attic was crooked and didnt seem to be braced correctly, recommend further evaluation by licensed professional
- Insulation in certain areas of attic were not sufficiently covering living space areas, may allow loss of heat or cooling from conditioned air, recommend correction by licensed professional

Exterior light was visible from attic, wood member within attic was crooked and didnt seem to be braced correctly, recommend further evaluation by licensed professional

Insulation in certain areas of attic were not sufficiently covering living space areas, may allow loss of heat or cooling from conditioned air, recommend correction by licensed professional

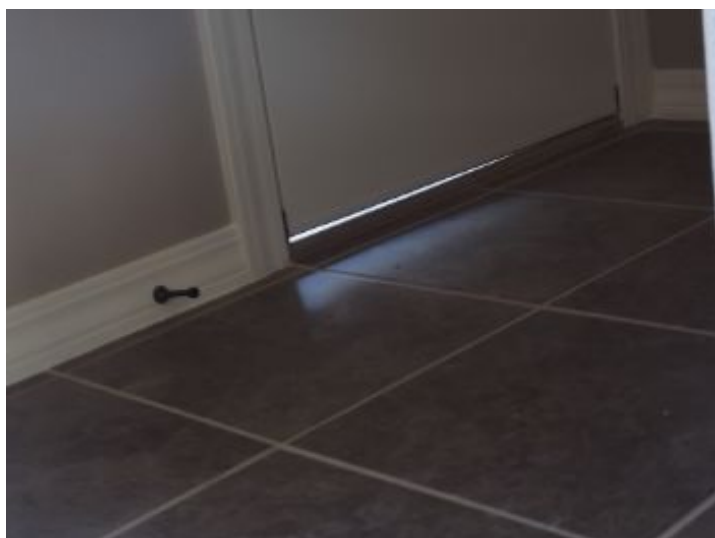
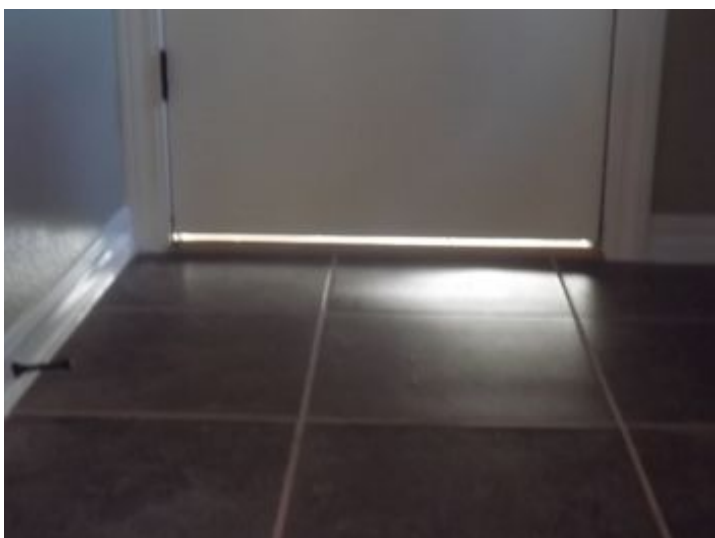
Comments: All doors were functional. **Both doors that lead into the garage seemed to have a gap from underneath allowing the escape of conditioned air to escape, recommend correction by licensed professional**

Both doors that lead into the garage seemed to have a gap from underneath allowing the escape of conditioned air to escape, recommend correction by licensed professional

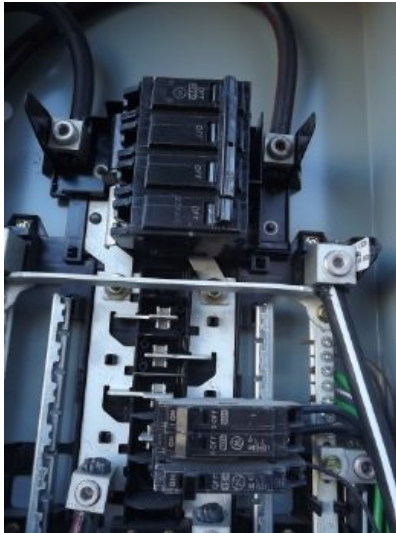
• Breakers appear to be loose in main panel (exterior) may cause branch circuits to not function properly, recommend correction by licensed electrician

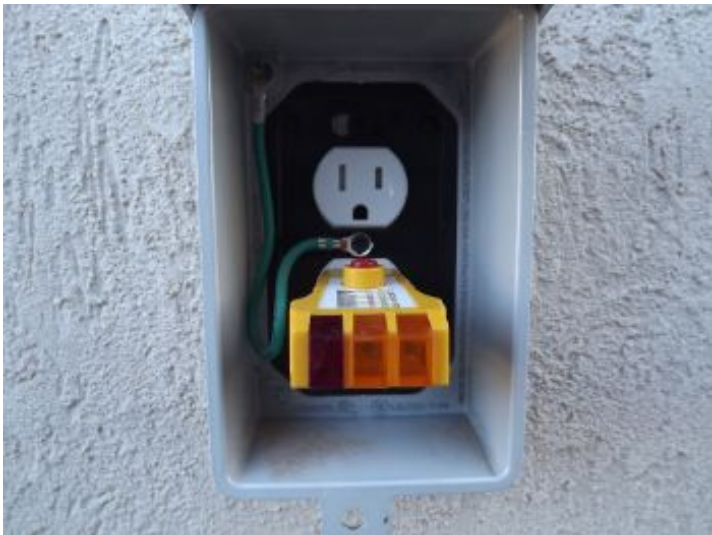
Exterior outlet (by main panel) was not functional, recommend correction by licensed professional

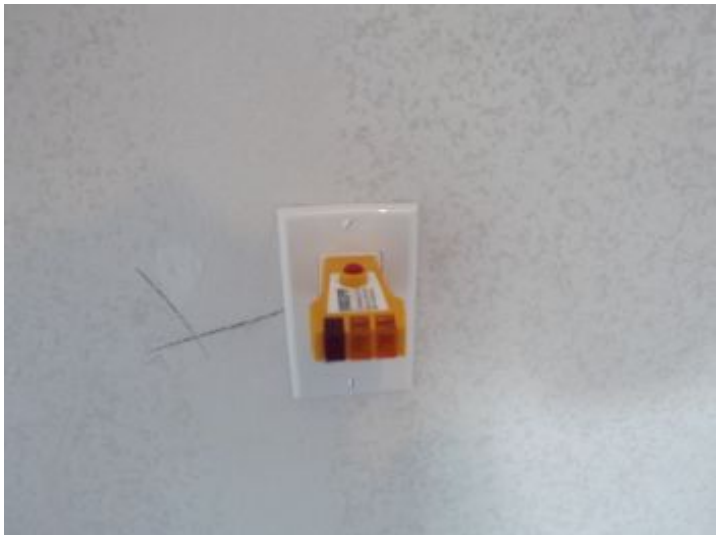
Outlets in single car garage were not functional, should be GFCI when functional, recommend correction by licensed professional

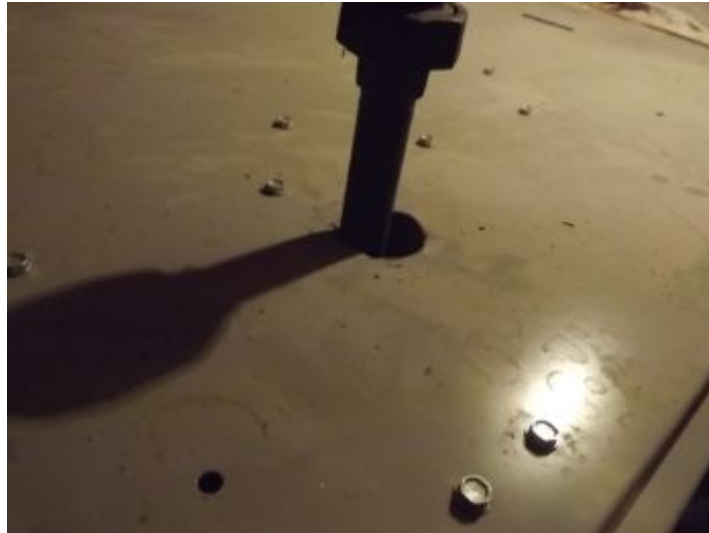
- Furnace was functional as need be
- Tray under furnace in attic seemed to have cellulose type insulation in it, this may cause the drain on tray to become clogged. This may lead to an overflow of water. Recommend correction.
- Recommend rubber grommet around gas line entering furnace

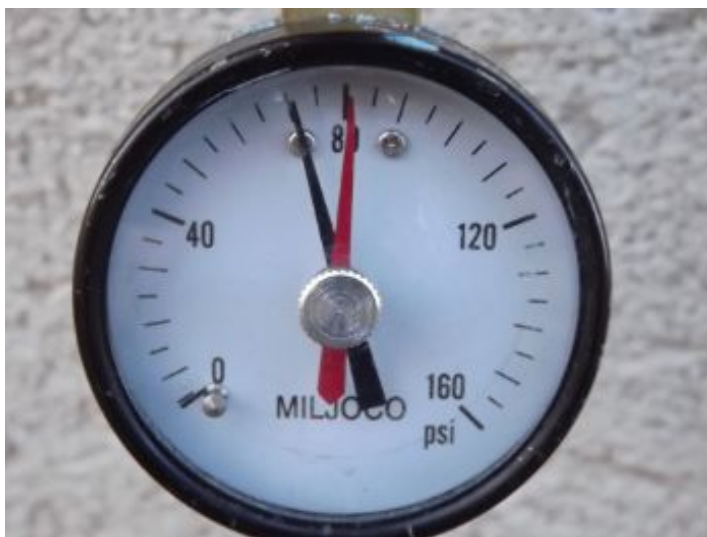
Static Water Pressure Reading: 78 PSI
