AAA Home and Termite Inspections

Property Inspection Report

12200 Inspectors Dr, El Paso, TX 79938
Inspection prepared for: John Doe & Jane Doe
Date of Inspection: 12/17/2012 Time: 8a
Age of Home: 2012 Size: 2000sq ft
Weather: 43deg F

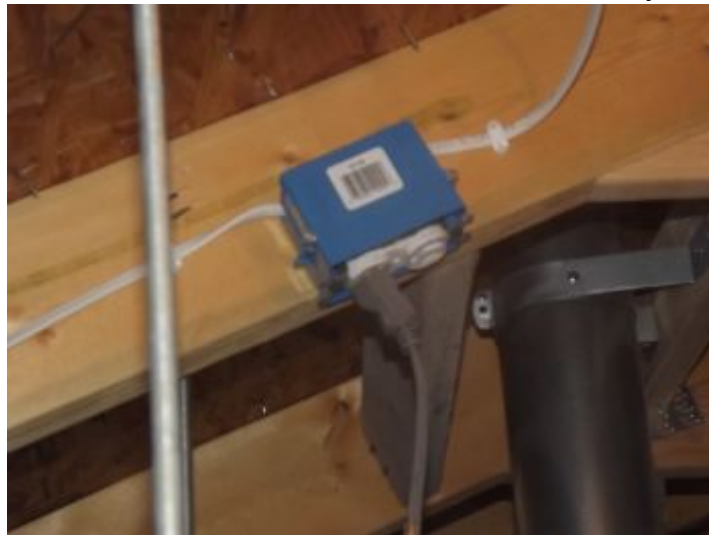
Outlets in single car garage were not functional, should be GFCI when functional, recommend correction by licensed professional
